Università
Ca' Foscari
Venezia

Dottorato di ricerca
in Scienze Chimiche
Ciclo XXVII
Anno di discussione 2014

**CHARACTERIZATION OF DETERIORATED PROTECTIVES AND
CONSOLIDANTS APPLIED ON STONE MATERIALS AND THEIR
EVENTUAL BIO-REMOVAL**

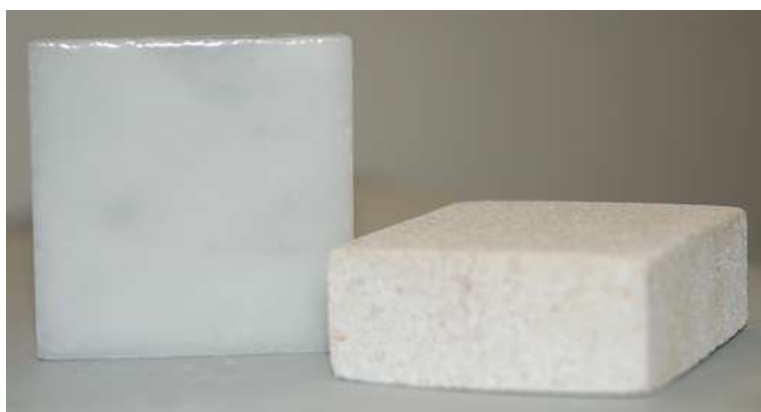
Figure 2.1: Carrara marble and Vicenza white limestone specimens

Prior to treatment, the supports were carefully washed and brushed in order to remove soluble salts. After that, they were dried in a ventilated oven and kept in a desiccator until the application of the products. Specimen dimensions were 5 x 5 x 1 cm (fig. 2.1).

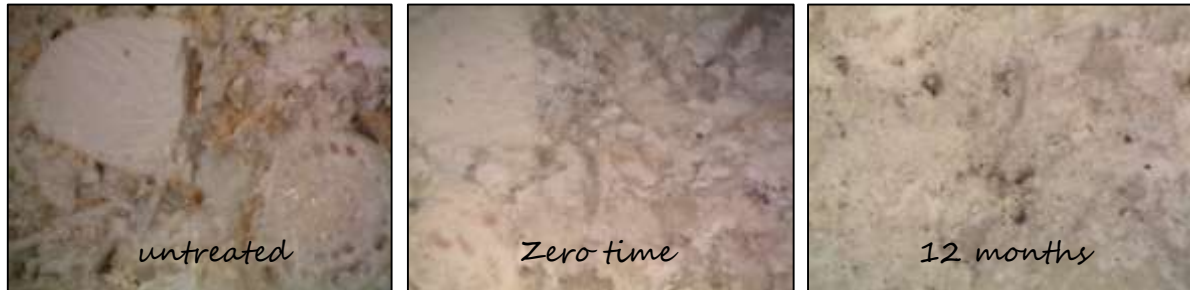
Although there was no surplus product on the treated specimens, the surface of the samples appeared whitened to the naked-eye. Study of the surfaces using an optical microscope showed the presence of acicular white crystals in the pores of the stone (fig. 3.1).

Figure 3.1: Micrographs of the same area of Vicenza white limestone untreated, treated with $Ba(OH)_2$ at zero time and after 12 months of outdoor exposure. Long side images 6.78 mm.

The aspect of the specimens did not change during exposure to outdoor conditions, but a diffuse microbiological growth was observed.

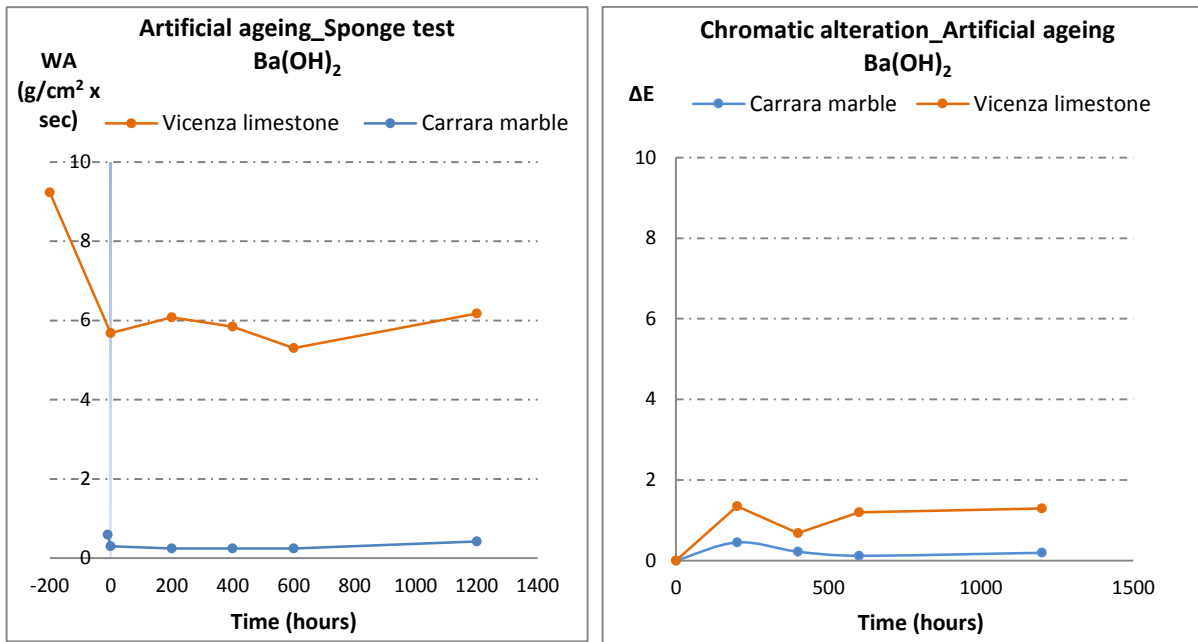
Graph 3.3: Water absorption variation (on the left) and trend of colour change (on the right) of surfaces treated with $Ba(OH)_2$ during UV exposure.

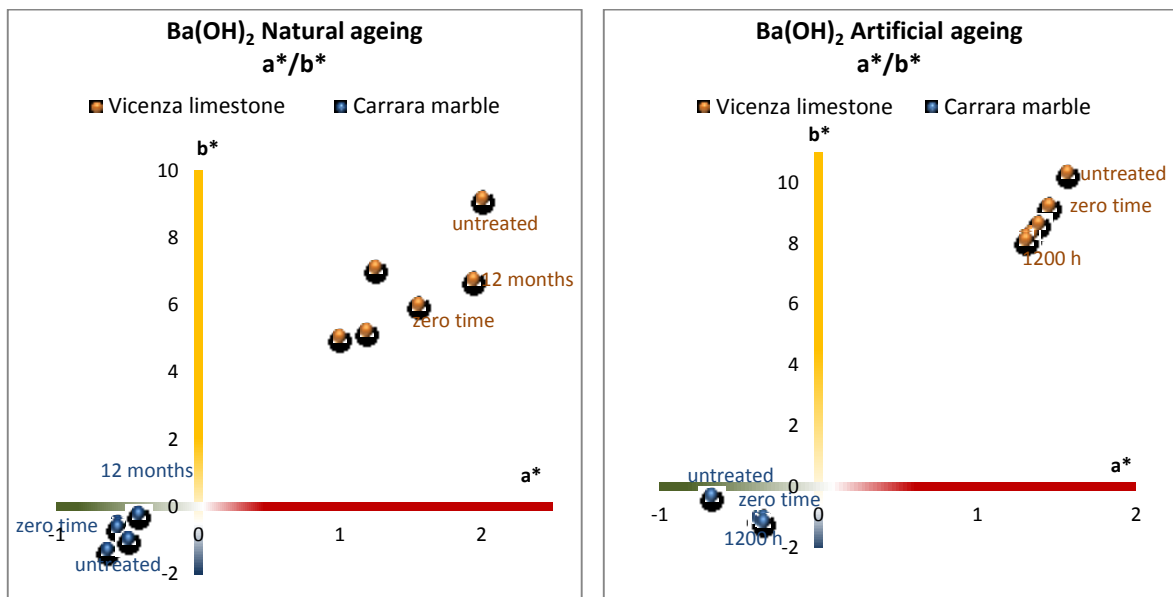
Graph 3.4: Colour graph of the chromatic alteration suffered by specimens treated with $Ba(OH)_2$ during exposure to outdoor conditions (on the left) and exposure to UV radiation (on the right).

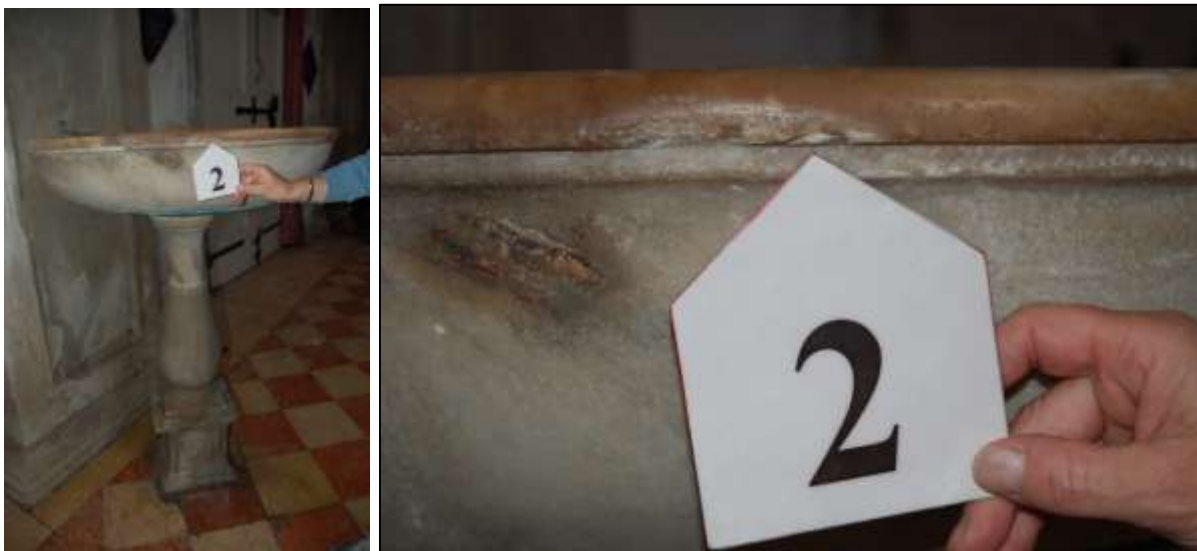
Number of micro-fragments sampled: 1 sample from the upper part of the font, adjacent to a spalled area.

Figure 3.7: Area of the sampling of the micro-fragment.

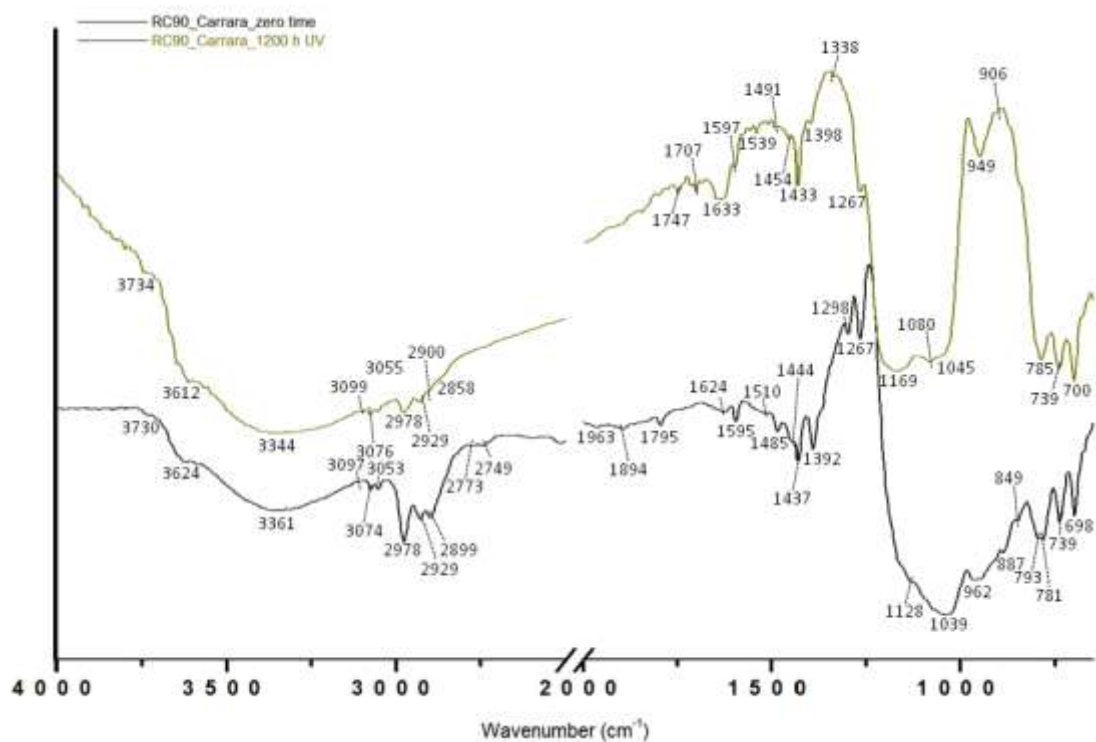
Figure 4.11: μ FTIR of Rhodorsil RC90 resin, applied to Carrara marble and exposed to UV rays for 1200 hours. Monitoring was undertaken at zero time (black line), and after 1200 h of exposure (dark yellow line).

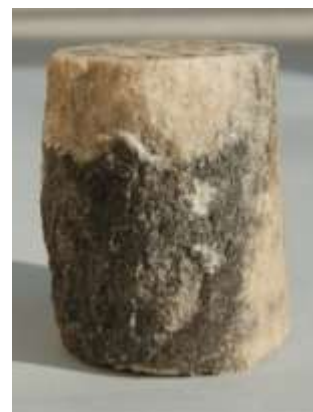
A small chip sampled from a column of the Ca' D'Oro façade in Venice carved from Proconnesian marble and treated in 1963 by Profs. L. Marchesini and L. Lazzarini using Sogesil XR893, by vacuum impregnation has been chemically analysed. The cross-section of a micro-fragment showed homogeneous distribution of the resin which is still present in the inter- and intra-grain spaces, confirmed by microscopic observations and SEM-EDS analysis (Fig. 4.21 and 4.22).

Figure 4.20: Fragment of a column of Ca D'Oro façade, Venice.

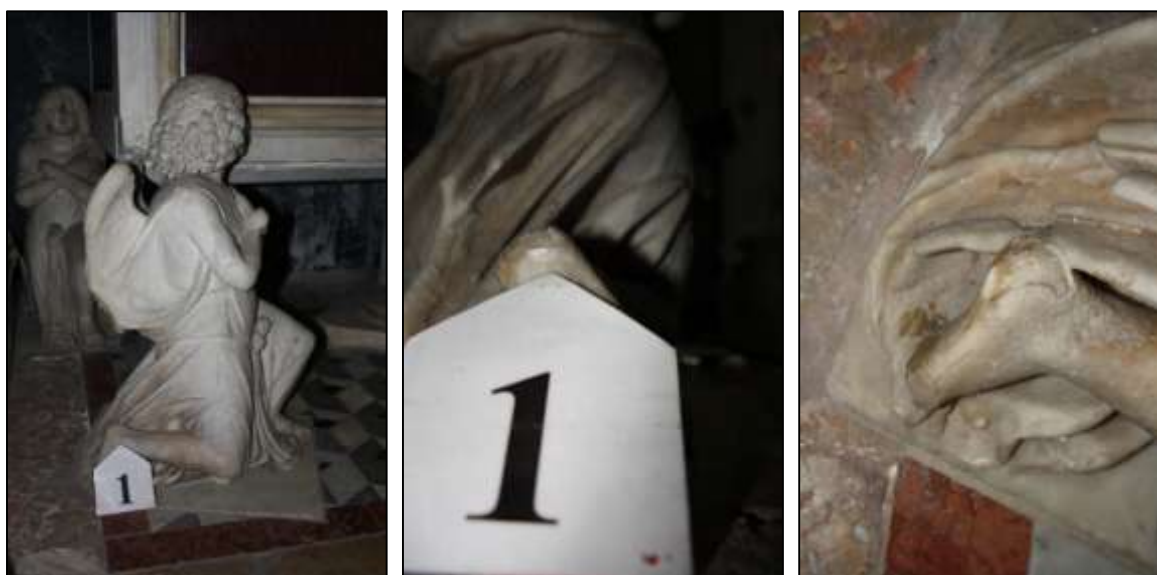
Number of micro-fragments sampled: 1 sample from the right-heel of the forward angel on the left, where there was a previous spall.

Figure 4.26: sampling of micro-fragment from the right-heel of the forward angel on the left.

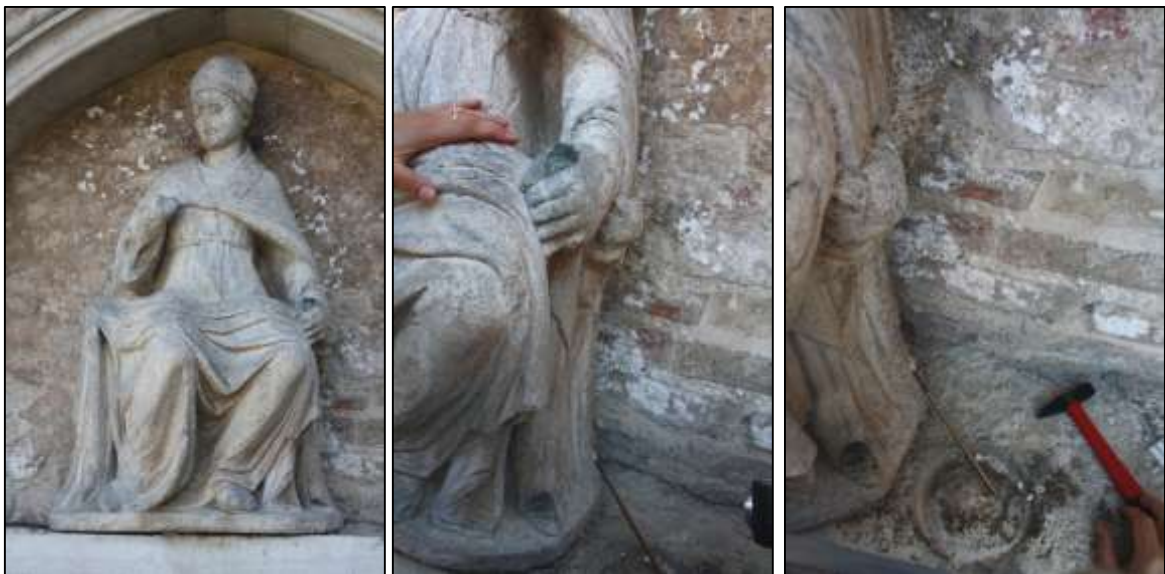
Number of micro-fragments taken: 1 sample from the right side of the statue, close to the base, where there was a previous spall.

Figure 4.30: Sampling of a micro-fragment from the right side of the statue, close to the base.

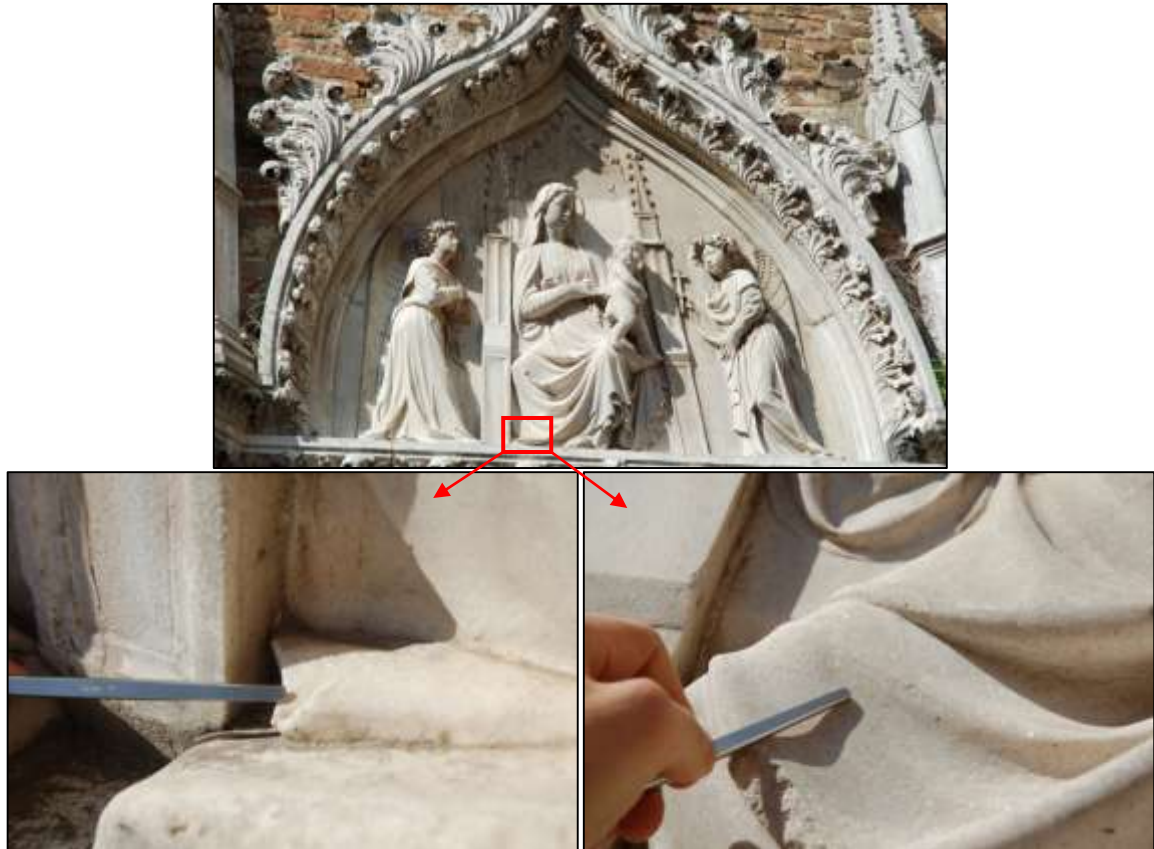
Figure 4.37: Sampling of a micro-fragment from lowest left part of the mantle of the Virgin Mary, adjacent to a previous broken area

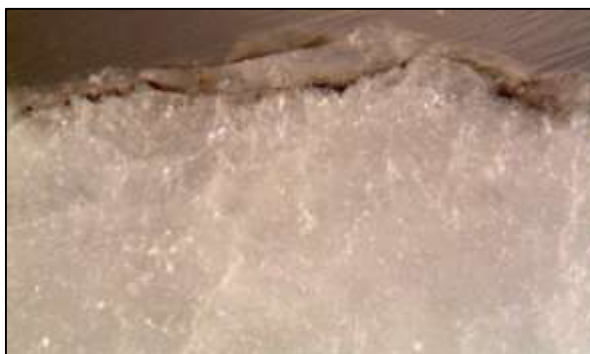
The micro-fragment sampled was observed and studied as found and in cross-section using stereo and optical microscopy. Dark superficial particles covered the sample surface, on which a superficial polymeric layer, deemed a protective feature, was observable by study of the cross-section.

Figure 4.38: Micrograph of the cross-section of the sample under the optical microscope. Long side image 1.03 mm.

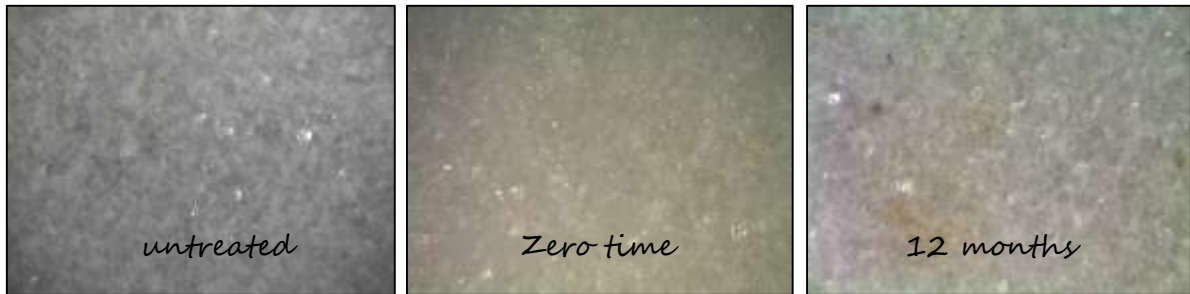
Observing the specimens microscopically after the treatment, it was observed in both Carrara marble and Vicenza limestone, with the naked eye, that there was a chromatic alteration of the treated surfaces and a yellowing effect (fig. 5.1 and 5.2). Initially, the

treatment covered homogeneously the stone substrate in a bright film but, during the ageing process it lost its brightness and it remained only in the inter and intra grain spaces as light-yellow crystals.

Figure 5.1: superficial aspect of untreated Carrara marble specimen, treated with PF3 at zero time and after 12 months of outdoor exposure. Long side images: 6.78 mm.

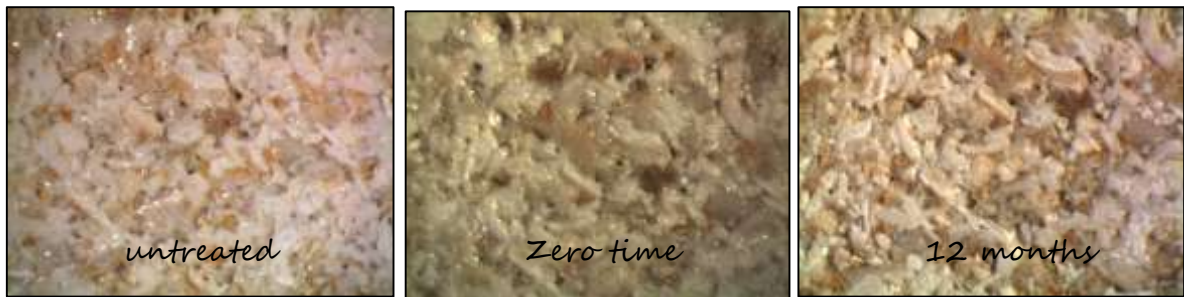
Figure 5.2: superficial aspect of untreated Vicenza limestone specimen, treated with PF3 at zero time and after 12 months of outdoor exposure. Long side images: 6.78 mm.

The chromatic alteration suffered by the stone due to the application of the treatment was confirmed by colour test. As it is possible to observe in graph 5.1, from zero time, the specimens exposed to outdoor conditions did not suffer chromatic variation noticeable to the naked-eye. The colour variation values increased gradually during time, probably due to the loss of film brightness and compactness. The treated specimens exposed to UV radiation changed significantly in the value of colour change during the first 200 hours and then it remained stable. The graph 5.2, especially in the case of artificial ageing, shows well the yellowing of the surfaces due to the application of the protective product. However the colour values tend to come back to the untreated values.

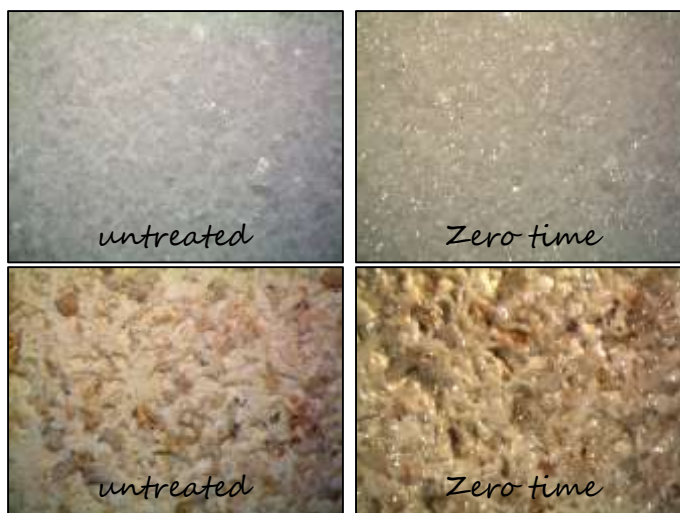
During outdoor exposure of the samples, it was observed that the polymeric film rapidly became dirty and many particles remained upon it. No biological growth had developed on the treated surfaces during the exposition time. UV radiation in the Solar box did not influence the morphological aspect of the cured film.

Figure 6.6: Superficial aspect of untreated (left) and treated (Acrylic 33) specimens (right) of Carrara marble and Vicenza white limestone. Long side images: 6.78 mm.

As colour changes with ΔE less than 5 are conventionally not visible to the naked eye [84], it is possible to assert that Paraloid B-72 gave higher colour variation than Acrylic 33 and that these variations are visually detectable.

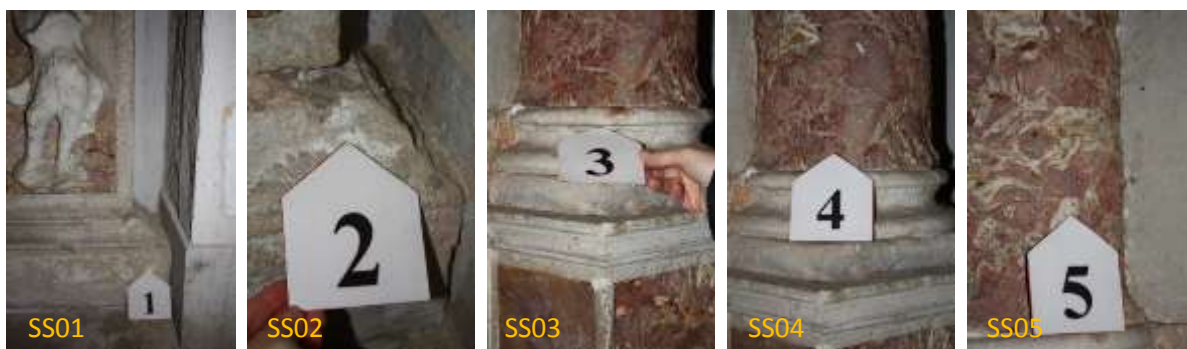
Figure 6.16: Area of the sampling of micro-fragments.

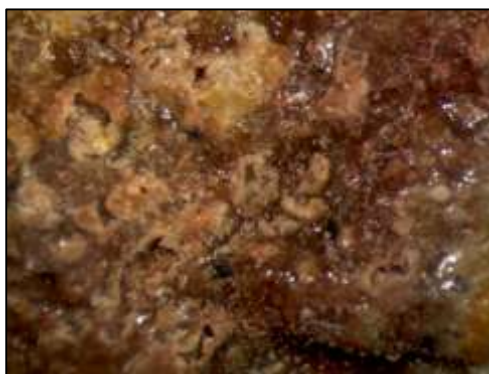
Figure 6.17: Micrography of sample SS04 at the stereomicroscopy. Long side image 4.23 mm.

Microscopic study of the samples showed a totally disaggregated surface, on which the bright superficial polymeric film was characterized by micro-cracks and swelling (fig. 6.17).

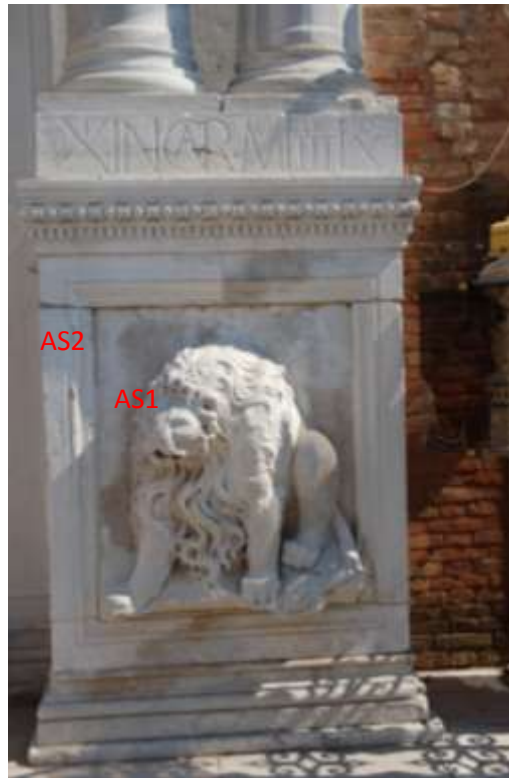
2 micro-scales from the relief of the lion to the right of the main portal

Figure 6.20: Area of the sampling of micro-fragments.

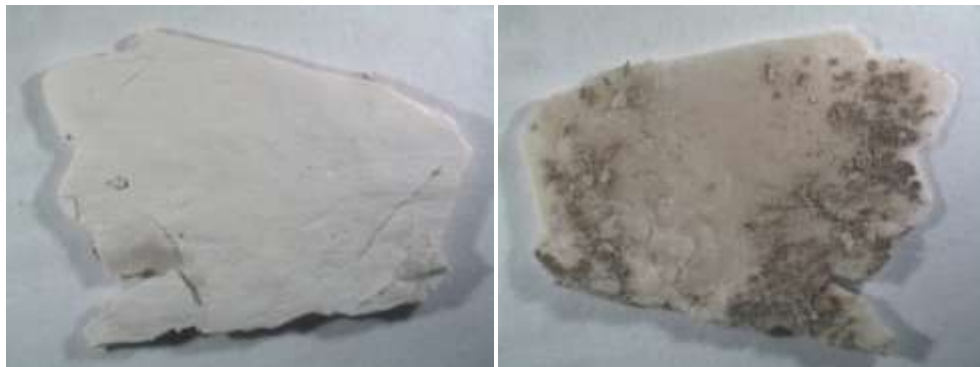
Figure 6.21: Front and rear of sample AS1

The samples showed a smoothed surface, opaque, with no microbiological growth, no cracks or fissures. The cross-section did not show a superficial layer related to the treatment.

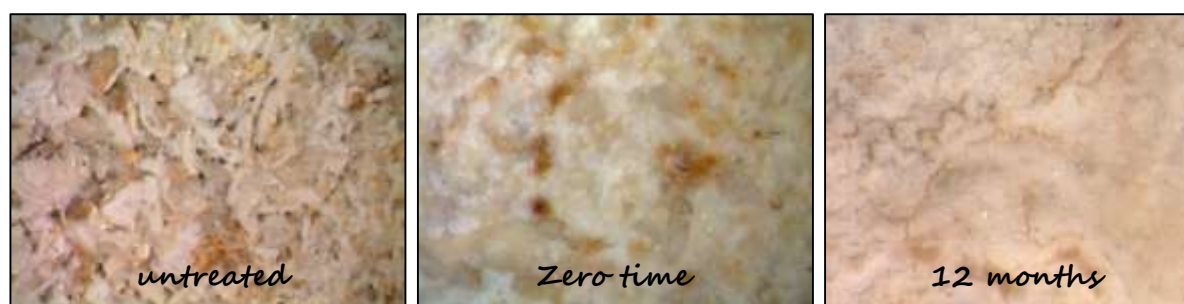
Concerning treated Vicenza white limestone, EP2101 suffered discolouration and cracking effects, and after 12 months it was still not possible to observe the original aspect of the stone. The visible alteration of the surface by the formation of a thin layer similar to a white compact powder distributed throughout the entire superficial area appeared on the stone after the first month, and increased during the following months. Cracking phenomena were observable from the sixth month of exposure, whereas fungal microbiological growth diffused from the third month.

Figure 7.5: micrographs of the same area of Vicenza white limestone untreated, treated with EP2101 at zero time and after 12 months of outdoor exposure. Long side images 6.78 mm.

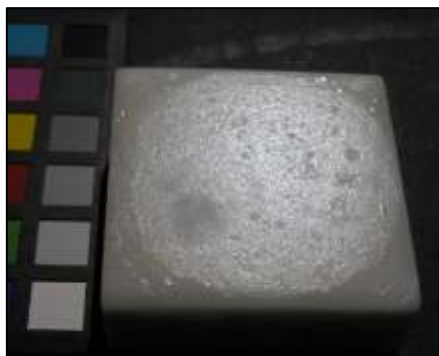
Figure 7.7: Picture of the imprinting of the sponge, during sponge test, on Carrara marble surface.

Moreover, it was demonstrated that treated Carrara marble, exposed to UV radiation, produced a smell during the sponge test, and the imprint of the sponge remained on the marble treated surface (fig. 7.7).

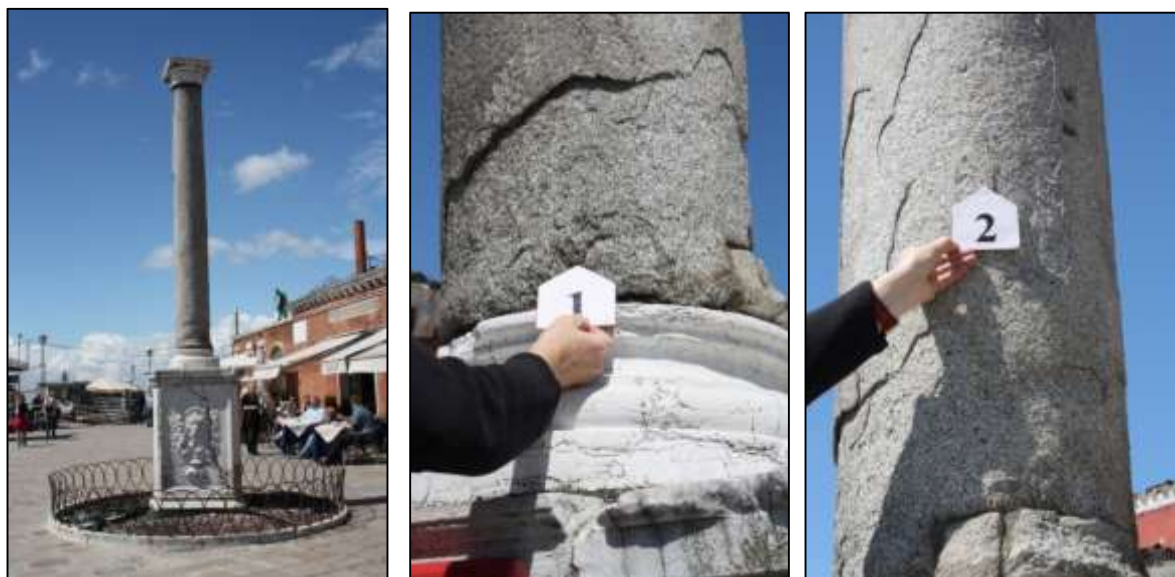
Number of micro-fragments sampled: 2 samples from different areas and height of the artifact

Figure 7.13: Area of the sampling of micro-fragments.

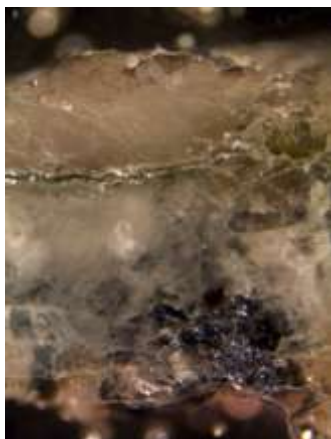
Studying cross-sections of the samples with the stereomicroscope, it was possible to observe the presence of a superficial polymeric film on the stone surfaces. The film was dark, disaggregated and raised from the substrate. The raising of the film contributed to the development of biological growth at the interface between the stone and film.

Figure 7.14: Micrography of CVM01 cross-section. OM. long side image 1.03 mm.

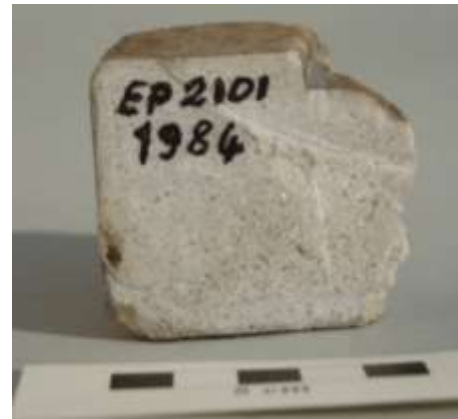
Moreover, the spectra were also compared with the spectrum obtained from the μFTIR analysis of EP2101, sampled from the specimen of Proconnesian marble from S. Marco Basilica (fig. 7.15), which was treated in 1984, in order to previously test the resin before its application *in situ*. The spectrum collected is comparable with those collected from the Vereri column, as shown in figure 7.16.

Figure 7.15: Specimen of Proconnesian marble from S. Marco Basilica treated in 1984 using EP2101.

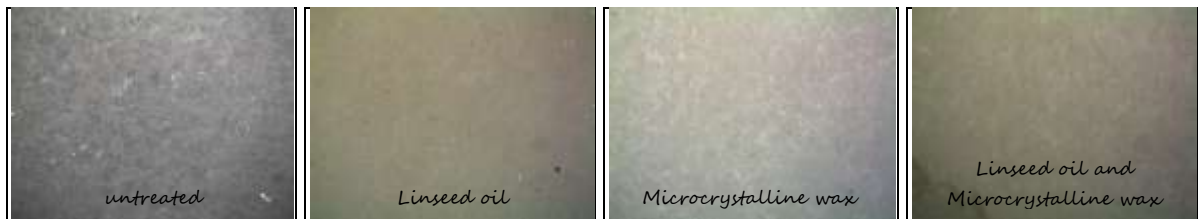
Macroscopically, as soon as the product dried, the specimens treated with linseed oil showed a yellowing of the surface noticeable to the naked-eye, whereas the aspect of the samples treated with microcrystalline wax looked unaltered.

Microscopically the oil was recognizable on the surfaces as light-yellow, small and bright crystals between calcite grains, while wax completely covered the stone surfaces and filled the superficial pores forming a white homogeneous patina. The specimens treated with linseed oil and protected with microcrystalline wax showed both characteristics, with observations showing a yellowing of the surface weakened by the presence of the wax on the surface (figure 9.1-2).

Figure 9.1: Micrographs of Carrara marble samples untreated, treated with linseed oil, microcrystalline wax, and linseed oil-microcrystalline wax at zero time. Long side images 6.78 mm.

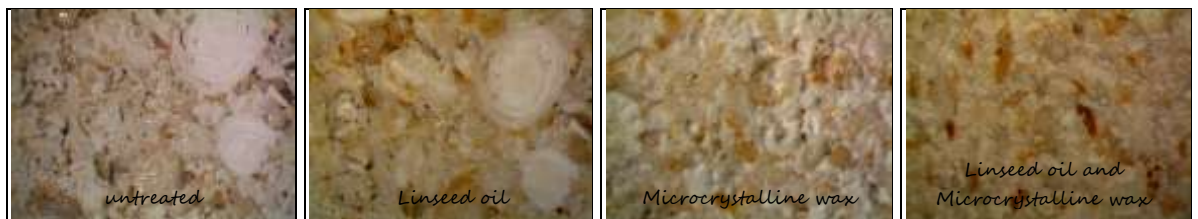
Figure 9.2: Micrographs of Vicenza limestone samples untreated, treated with linseed oil, microcrystalline wax, and linseed oil-microcrystalline wax at zero time. Long side images 6.78 mm.

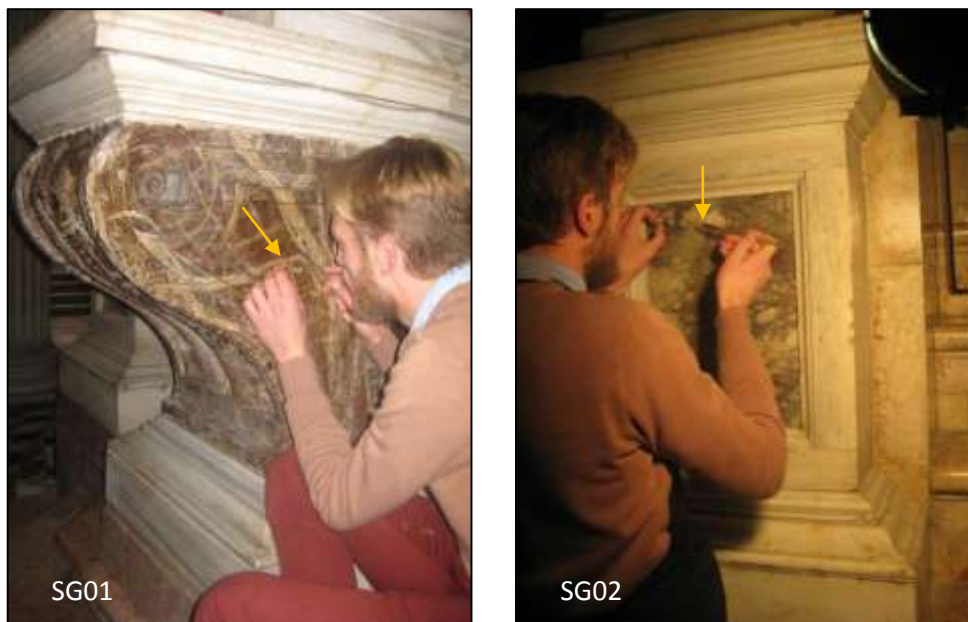
Figure 9.11: Sampling of superficial dark patina from different areas on the High Altar

The sampling was carried out using a scalpel.

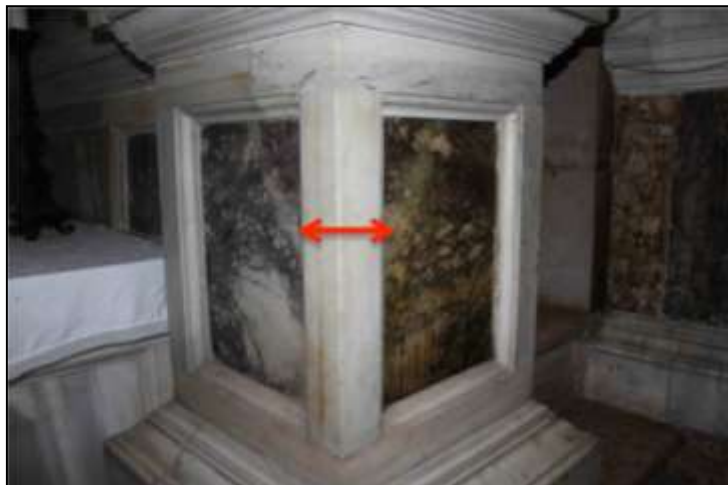
The coating appeared thick and waxy to the touch. Drip lines were visible suggesting that it was applied carelessly, thickly and in a liquid form.

Figure 9.12: Dark coating seen on the marble panel on the right probably a past protective treatment.

The dark coating seen on the marble panel in the right of figure 9.12 was possibly a discoloured oil/wax previously applied to the surface. This was a common ‘housekeeping’ treatment in the past when a combination of beeswax and linseed oil was used as a polish for marble. The substance has only been applied to the front and the sides of the altar, further suggesting that it was a past surface treatment intended to improve the appearance of the stone for visitors to the church. If this was the nature of the coating, it was likely that the linseed oil has been yellowed over time and the wax had attracted and held dust/dirt. An Ultra Violet lamp was used to analyse the nature of the coating.

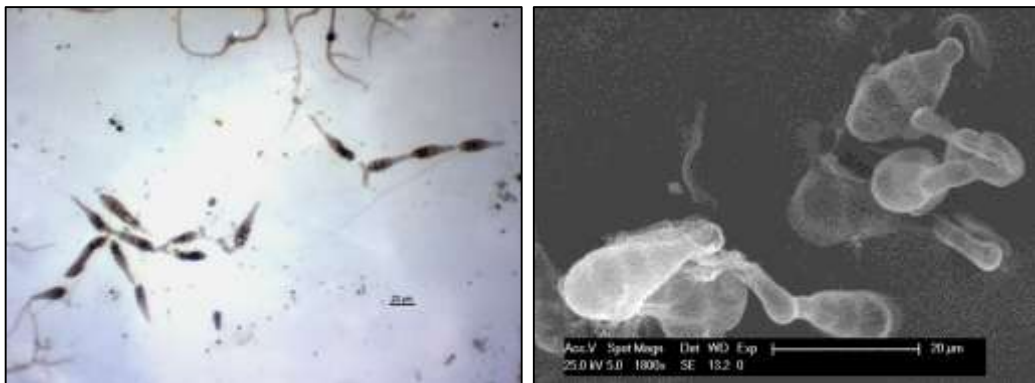
Acrylic resins: *Paraloid B-72 – Acrylic 33*; epoxy resin: *EP2101*; silicon based compounds: *Rhodorsil RC90 - Rhodorsil RC80 – EAS 40 – Rhodorsil H 224 - Hydrophase*; nano-particle compounds: *PF3*; inorganic treatment: *Ba(OH)₂*; fluorinate products: *Fluorophase*; Traditional and modern treatments: *Linseed oil – microcrystalline wax – Linseed oil and microcrystalline wax*; untreated samples.

2. Hypothesis: *Penicillium Spp.*

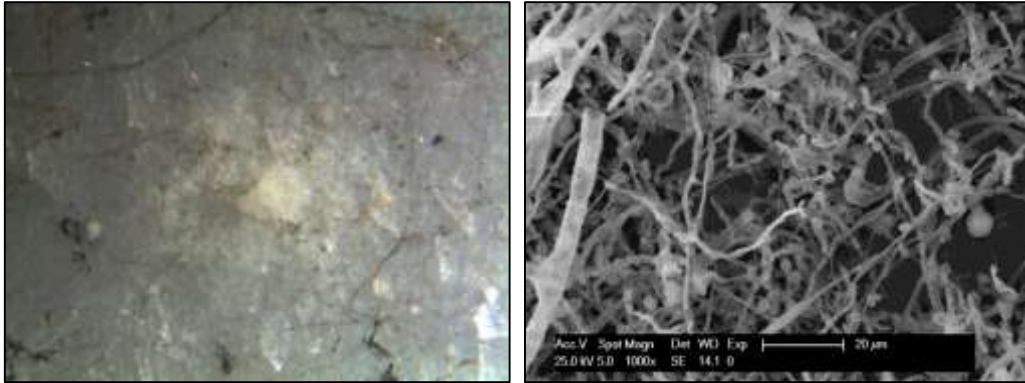
Silicon based compounds: *Rhodorsil RC90 - Rhodorsil RC80 – EAS 40 – Rhodorsil H 224 - Hydrophase*; nano-compounds: *PF3*; fluorinate products: *Fluorophase*; Traditional and modern treatments: *Linseed oil – Linseed oil and microcrystalline wax*.

14. *Hypothesis*: not yet identified

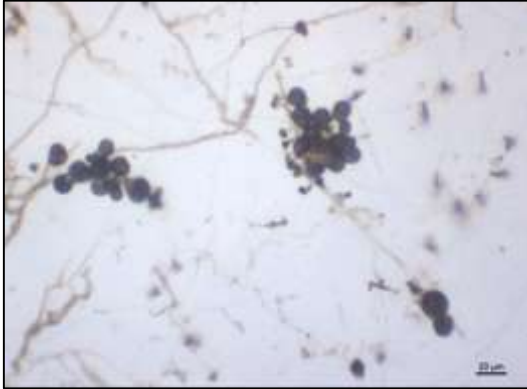
Acrylic resins: *Acrylic 33*; Silicon based compounds: *Rhodorsil RC90 – EAS 40*; nano-compounds: *PF3*; Traditional and modern treatments: *Linseed oil –Linseed oil and microcrystalline wax*; untreated samples.

17. Hypothesis: not yet identified

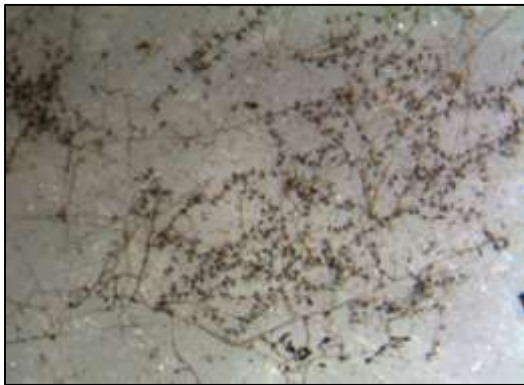
Silicon based compounds: *Rhodorsil RC80*

18. Hypothesis: not yet identified
